Final Report  
Jessica Cherry  
27 January, 2017

**Aerial monitoring of flood inundation and river ice breakup processes  
UCAR Subaward Z16-23490**

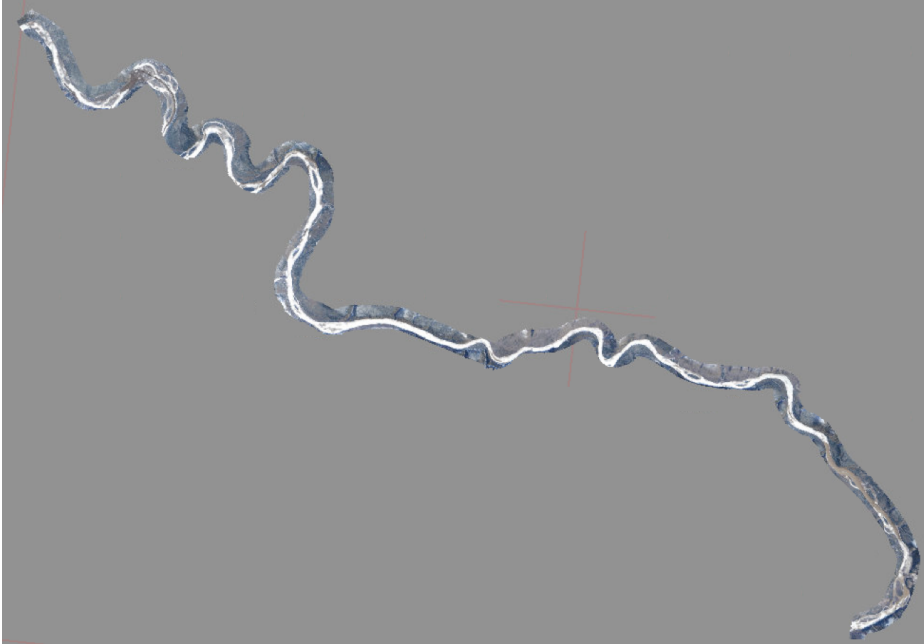
Figure 2: The orthomosaic of the Upper Yukon from Dawson City to Circle on April 21, 2016.

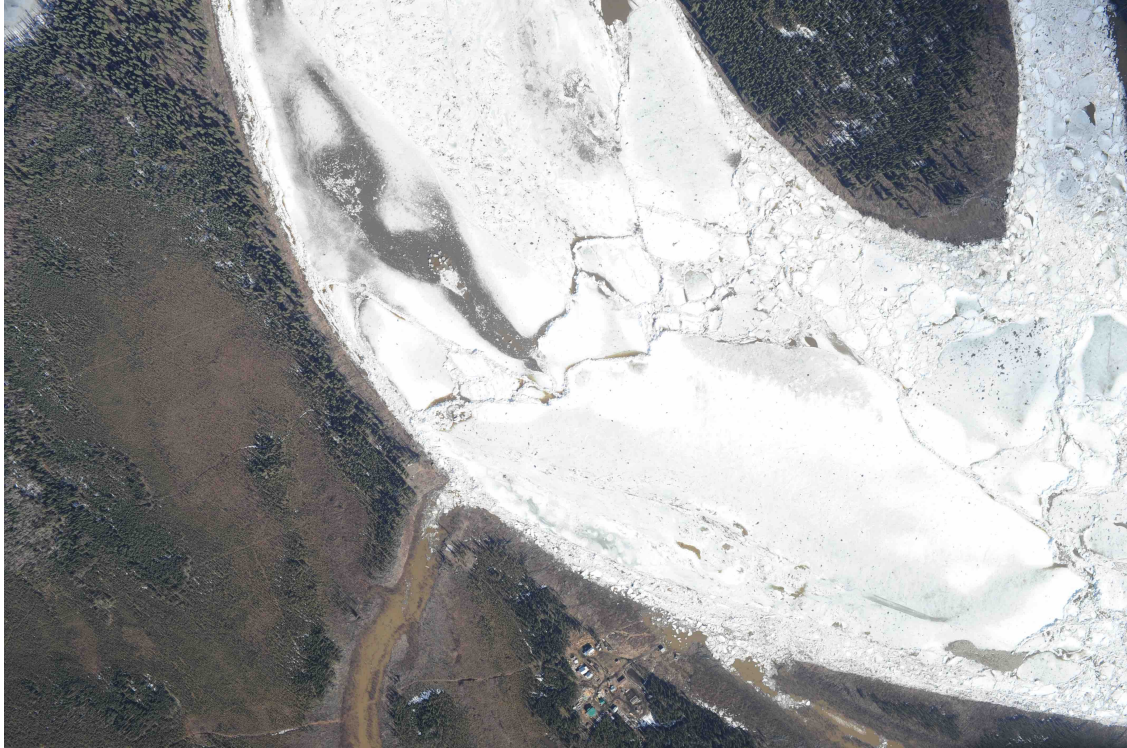
Figure 7: A close up of an ice jam near Eagle at Calico Bluff taken by Cherry during the 2016 flights. The homestead with water encroaching can be seen at the bottom of the image. A story with this ice jam image was published in the Fairbanks and Anchorage newspapers.

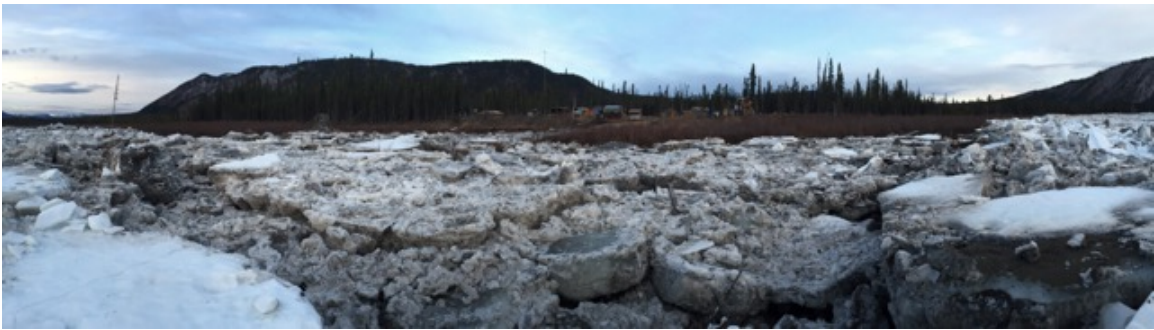
Figure 8: A view of the ice jam from the homesteader.
